TRADITIONAL RESERVE STUDY PROPERTY CONDITION ASSESSMENT

Turtle Lake Golf Colony
180 & 101 Forest Lakes Boulevard
Naples, Florida 34105

Project Number 2323762

November 10, 2023

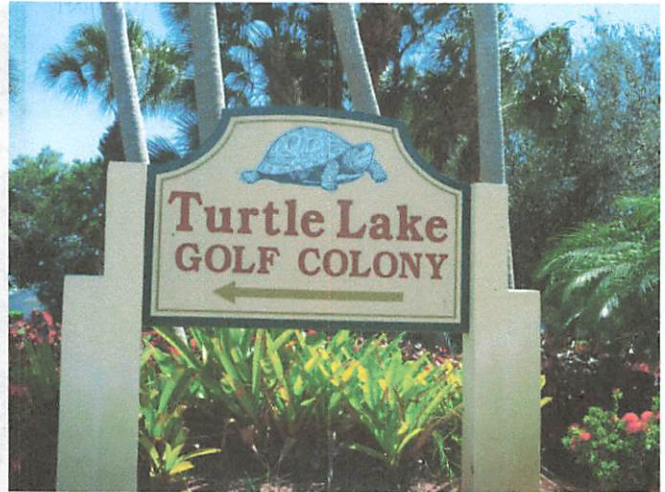
PHOTO 1

PROPERTY IDENTIFICATION SIGN

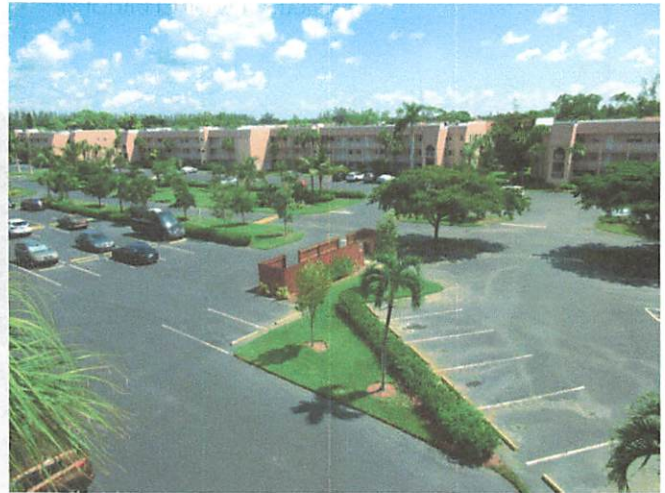
PHOTO 2

GENERAL VIEW OF PROPERTY

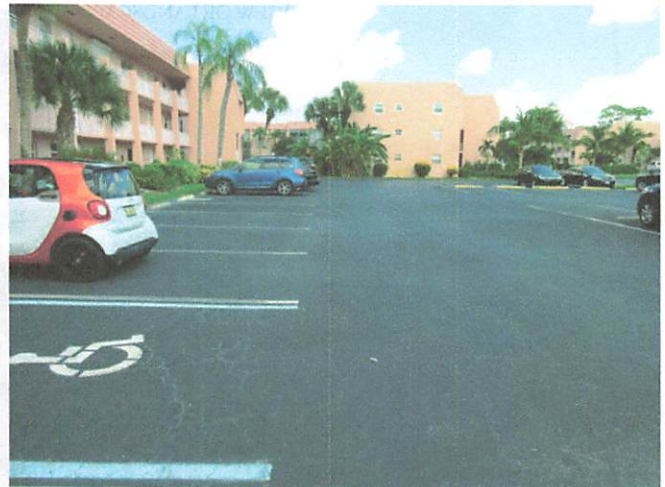
PHOTO 3

PARKING AND PAVEMENT

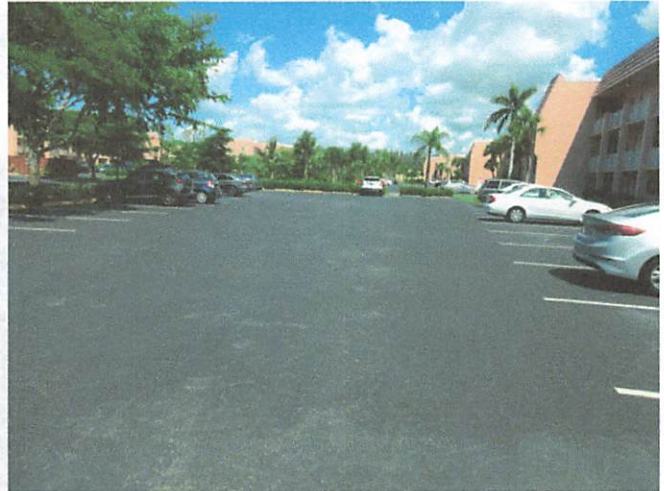
PHOTO 4

GENERAL VIEW OF PARKING AND PAVEMENT

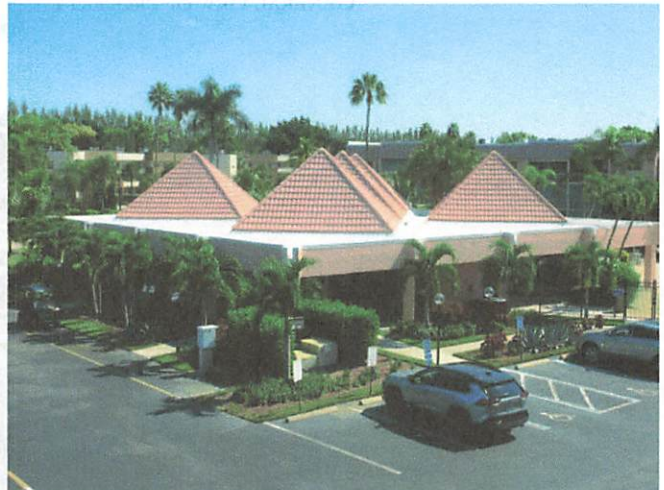
PHOTO 5

GENERAL VIEW OF CLUBHOUSE

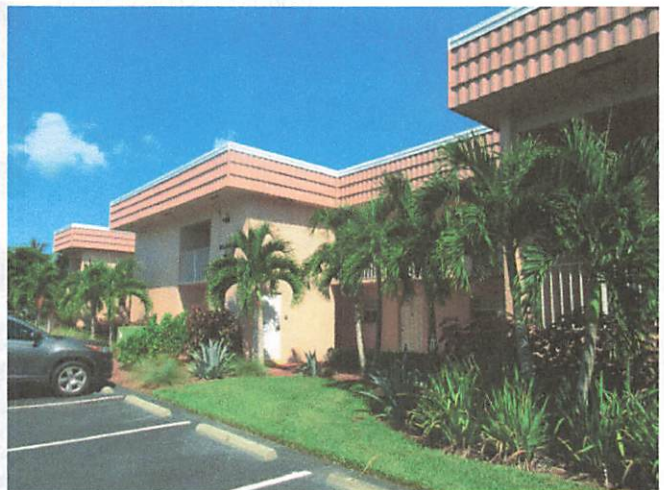
PHOTO 6

Item	Description/Observations/Comments
Landscaping	<p>Landscaping at the Property includes various mature trees, bushes, and lawn. An automatic underground irrigation system is provided.</p> <p>Landscaping appears to be in good condition, with no significant deficiencies noted. The irrigation system was reported to be in good operating condition. Funds for upkeep and upgrades of landscaping components have been spread throughout Replacement Reserves Cost Estimate Table, adopting the straight-line accounting method to ensure the availability of funds at the end of the replaced element's Expected Useful Life (EUL) beyond the evaluation period.</p>
Sanitary Sewer	<p>The sanitary sewer system discharges into the municipal sewer system.</p> <p>Due to hidden conditions, the site sanitary sewer system could not be evaluated. However, the building representative indicated that the system appears to be in good condition, with no problems reported.</p>

VIEW OF LANDSCAPING

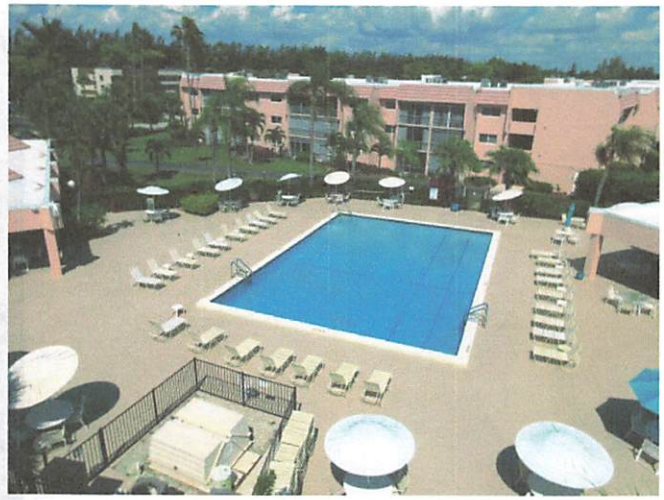
PHOTO 7

GENERAL VIEW OF SWIMMING POOL

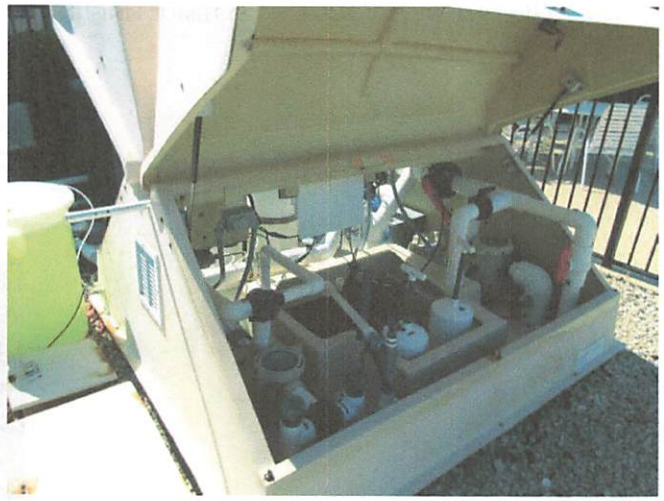
PHOTO 8

Pool Equipment	<p>The swimming pool equipment consists of a heater, water filter and circulating pump.</p> <p>The swimming pool equipment was noted to be in good operating condition. Based on the EUL of 10 years, replacement of the swimming pool equipment should be anticipated during the evaluation period. Funds have been spread throughout Replacement Reserves Cost Estimate Table, adopting the straight-line accounting method to ensure the availability of funds at the end of the replaced element's EUL, beyond the evaluation period of this assessment.</p>
Tennis Court	<p>The Property has two tennis courts located at the northwest portion of the site. The court surfaces are constructed of concrete and surrounded by chain-link fencing. The tennis courts were resurfaced in 2018.</p> <p>The tennis court surfaces were noted to be in good condition. Based on the EUL of 10 years, resurfacing should be anticipated during the evaluation period. Funds have been spread throughout Replacement Reserves Cost Estimate Table, adopting the straight-line accounting method to ensure the availability of funds at the end of the replaced element's EUL, beyond the evaluation period of this assessment.</p>

GENERAL VIEW OF SWIMMING POOL EQUIPMENT

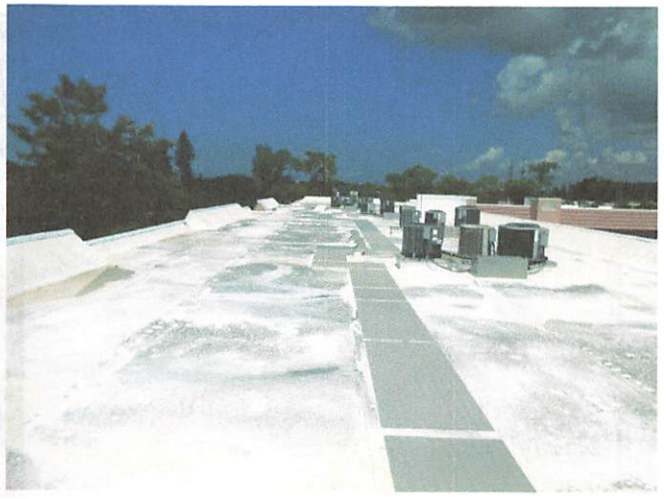
PHOTO 9

Roof	<p>The roofs are classified as low-slope (flat), covered with thermoplastic polyolefin (TPO) membrane over rigid insulation and plywood decking supported by wood framing. Fiberglass mansard surrounds the roof.</p> <p>According to the Property representative, the roof at Building 1 is approximately 18 years old, and roofs at the remaining buildings are 10 to 12 years old. The roofs were noted to be in generally good condition with no significant deficiencies noted. Based on the EUL of 20 years for TPO roofs, replacement is anticipated during the evaluation period. Funds have been allocating throughout the reserve period, adopting the straight-line accounting method to ensure the availability of funds at the end of the element's EUL, beyond the evaluation period of this assessment.</p> <p>Please note that the extent of the roof evaluation did not include any sampling and/or testing involved therefore comments made regarding the condition of the roof are limited to visual observation as well as historical information provided by site contact and/or Property respondent. Should a more comprehensive investigation be required, the services of a certified roofing consultant should be considered.</p>

VIEW OF ROOF COVERING

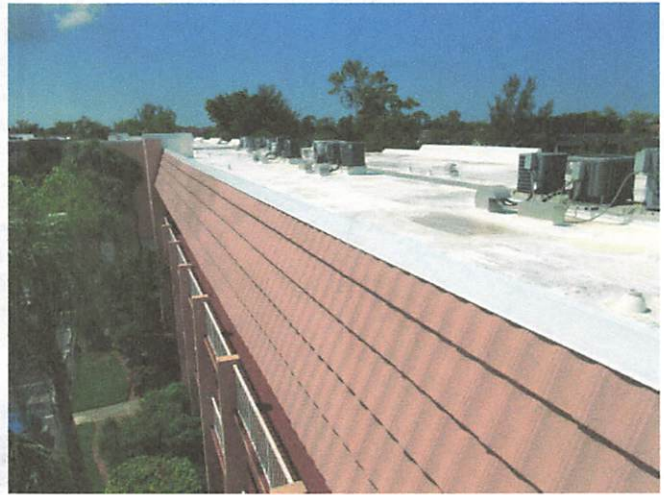
PHOTO 10

GENERAL VIEW OF MANSARD SYSTEM

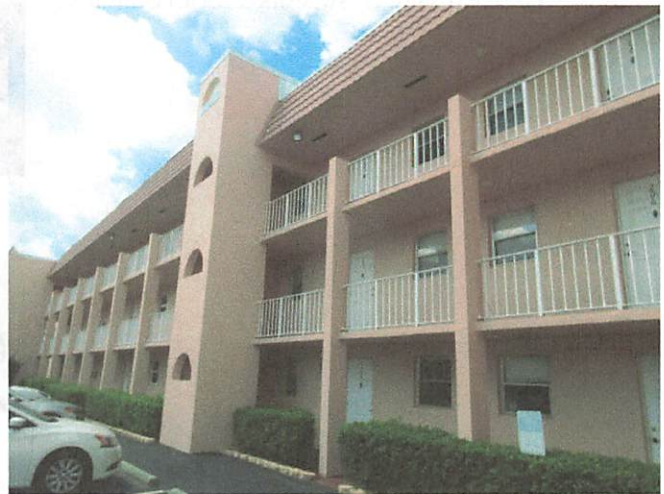
PHOTO 11

GENERAL VIEW OF BUILDING EXTERIOR FINISHES

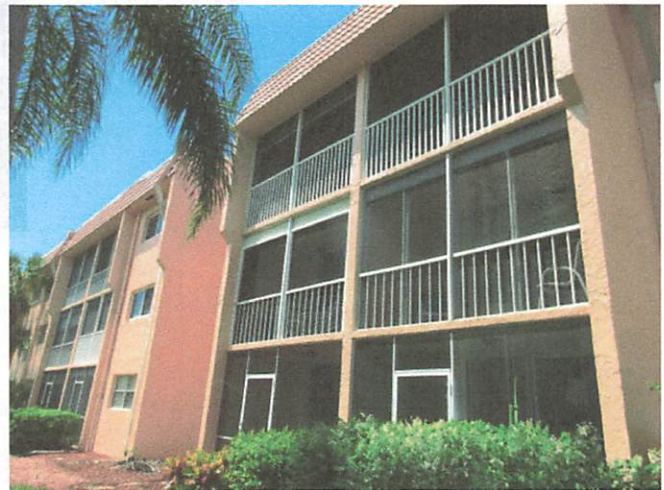
PHOTO 12

VIEW OF BUILDING EXTERIOR FINISHES

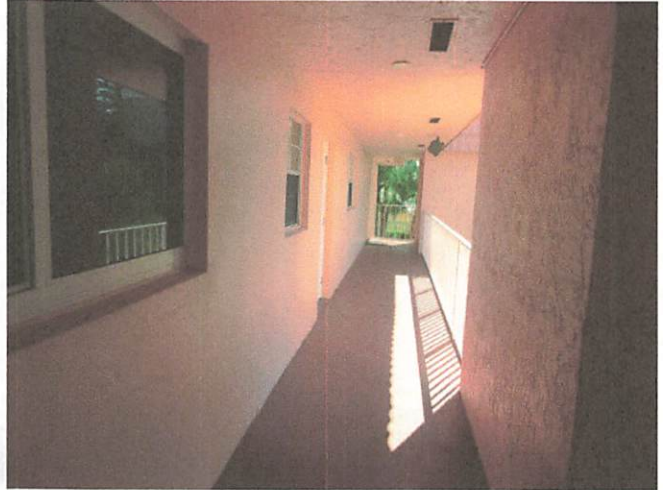
PHOTO 13

Elevated Walkways	<p>The elevated walkways are supported by the building structural system. They include concrete decking with aluminum railing.</p> <p>The elevated walkways appeared to be in good condition. Minor areas of deficiency were noted during our site visit that are addressed in conjunction with the exterior façade painting and waterproofing applications.</p>
Windows	<p>The windows consist of punch-through, aluminum-framed double-glazed, double-hung units. Most of the units have reportedly been replaced with impact-resistant rated windows.</p> <p>The windows appeared to be in generally good condition with no significant deficiencies noted, requiring only routine maintenance over the evaluation period.</p> <p>Windows at the condominiums are the responsibility of the respective unit owners to maintain and replace.</p>
Doors	<p>The exterior entry doors are constructed of insulated fiberglass-clad units set in composite framing.</p> <p>The doors appeared to be in generally good condition with no significant deficiencies noted, requiring only routine maintenance over the evaluation period.</p> <p>Doors at the condominiums are the responsibility of the respective unit owners to maintain and replace. However, painting applications are the responsibility of the association.</p>

VIEW OF ELEVATED WALKWAY

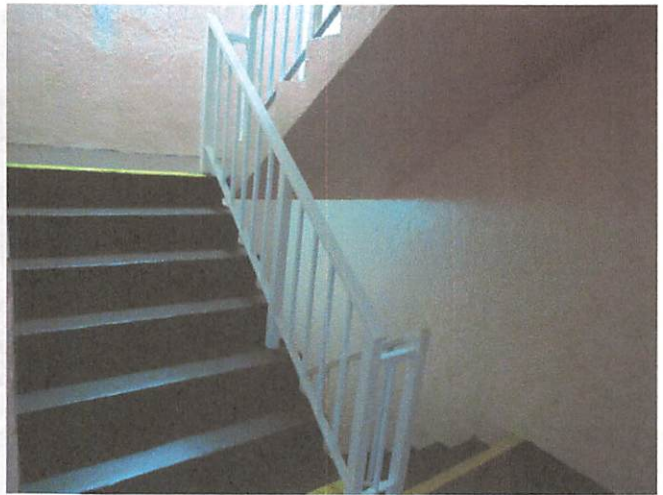
PHOTO 14

Escalators	<p>There are no escalators at the Property.</p>
Stairs	<p>The exterior stairs consist of poured concrete with closed risers and aluminum railing.</p> <p>The stairs appeared to be in generally good condition requiring only routine maintenance over the evaluation period.</p>

VIEW OF EXTERIOR STAIRS

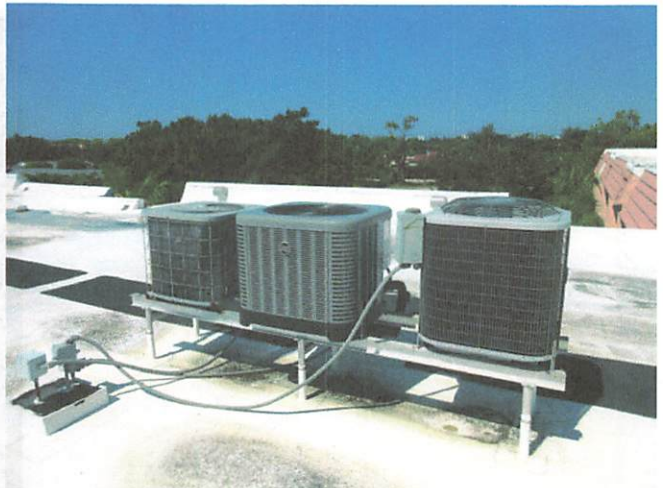
PHOTO 15

Item	Description/Observations/Comments
HVAC	<p>Cooling and heating are supplied by individual electric forced-air furnaces with split-system air-conditioning condensing units.</p> <p>HVAC at the dwelling units is the responsibility of the condominium owners to maintain and replace. HVAC equipment replacement in the common area should be anticipated during the evaluation period. Funds have been spread throughout the Replacement Reserves Cost Estimate Table, adopting the straight-line accounting method to ensure the availability of funds at the end of the replaced element's EUL, beyond the evaluation period of this assessment.</p>
Plumbing Systems	<p>The building's plumbing systems include the incoming water service and the hot and cold-water piping system; the sanitary sewer including the soil, waste, and vent system, as well as the bathroom fixtures and water heaters.</p> <p>The domestic water supply piping within the subject buildings is reported to be a combination of copper and galvanized steel. The soil, waste and vent system within the buildings is reported to be PVC.</p> <p>The plumbing systems appeared to be in good to fair condition. The water pressure, quantity of hot and cold water, and drainagewere reported to be adequate. No abnormal plumbing problems were reported by the Property representative.</p> <p>The galvanized piping at the Property is over 40 years old. The EUL of galvanized piping ranges between 40 and 50 years. Existing piping of this age is brittle and susceptible to breakage when repairs are made. Furthermore, there is a good chance that the piping is internally scaled which leads to reduced water pressure, water discoloration and staining of the fixtures. Given the age of the system and the noted areas of potential concern, we recommend considering systematic replacement of the older lines. Funds have been spread throughout the Replacement Reserves Cost Estimate Table, adopting the straight-line accounting method.</p>

GENERAL VIEW OF HVAC EQUIPMENT

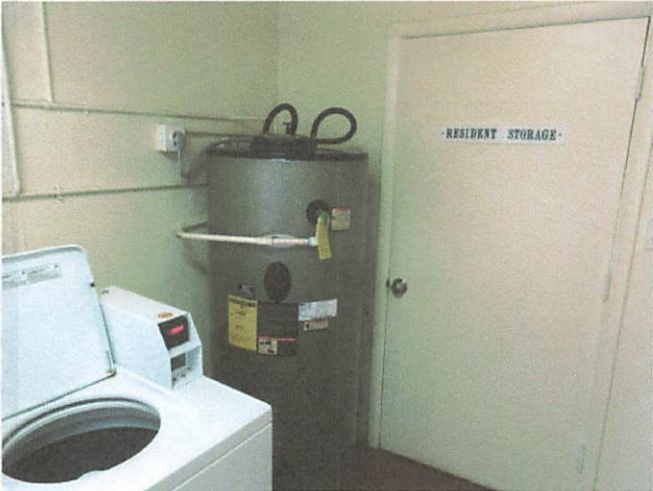
PHOTO 16

VIEW OF DOMESTIC WATER HEATER

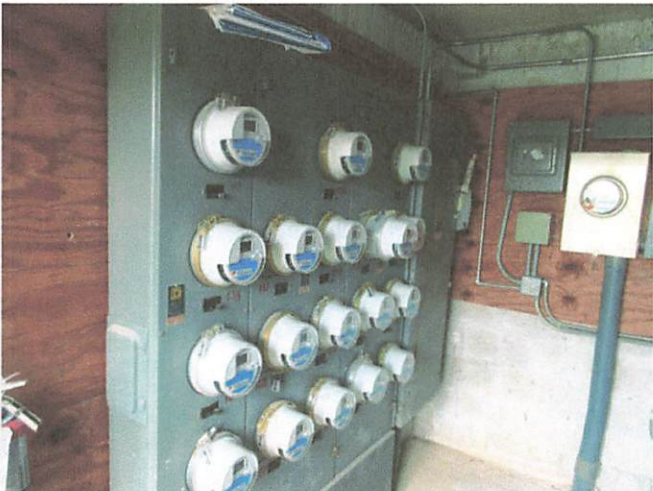
PHOTO 17

Item	Description/Observations/Comments
Electrical Service	<p data-bbox="609 306 1438 431">Electrical service enters the building from utility-company owned transformers, providing 100-Ampere, 120/240-Volt, single-phase, three-wire service to the individual units. The distribution wiring was noted to be copper. GFCI outlets were noted in kitchens, bathrooms, and wet areas.</p> <p data-bbox="609 442 1438 597">The electrical system components were observed to be in good condition. In general, the electrical systems for the Property, including main switchboards, transformers, distribution circuit breaker panels, contactors, lighting, and wiring system were noted to be adequately sized for the intended use of the facility.</p> <p data-bbox="609 608 1438 702">Electrical systems and installations within the dwelling units are reported to be the responsibility of the respective condominium unit owner to maintain and replace.</p> <p data-bbox="609 712 1438 1347">Several main electrical breaker panels (Buildings 1, 3, and 8) were noted to be model Sab-Lok manufactured by Federal Pacific Electric (FPE). According to the Property representative, there have been no issues associated with the panels. We recommend the monitoring of FPE circuit breakers as part of routine maintenance, including understanding which outlets and products are connected to each circuit, and never overloading any electrical circuit by connecting too many products to the circuit. In addition, be particularly careful not to connect several products that demand high current (such as heating appliances) to a low amperage circuit. When inspecting circuits, look for situations in which circuits may have overloaded. Comply with local building codes in wiring or adding electrical circuits. Make sure the wiring and devices used in the circuit are connected to a circuit breaker or fuse of the proper size. Immediately disconnect any electrical product if problems develop. Investigate to determine why a circuit breaker trips. Do not simply reset the breaker. If a breaker trips, it is often a warning that the circuit is overloaded. Check the circuit for causes of overloading (for example, too many appliances plugged in, a malfunctioning product, a short circuit). Any malfunctioning breakers should be replaced immediately.</p> <p data-bbox="609 1357 1438 1544">In addition, based on the age of the Property, primary common area electrical systems upgrade is anticipated during the evaluation period. Funds have been spread throughout the Replacement Reserves Cost Estimate Table, adopting the straight-line accounting method to ensure the availability of funds at the end of the replaced element's EUL, beyond the evaluation period of this assessment.</p>

VIEW OF ELECTRICAL EQUIPMENT

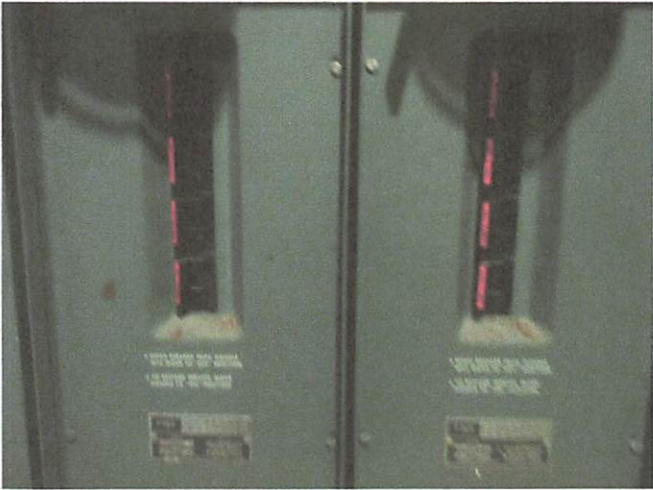
PHOTO 18

VIEW OF STAB-LOK BREAKERS

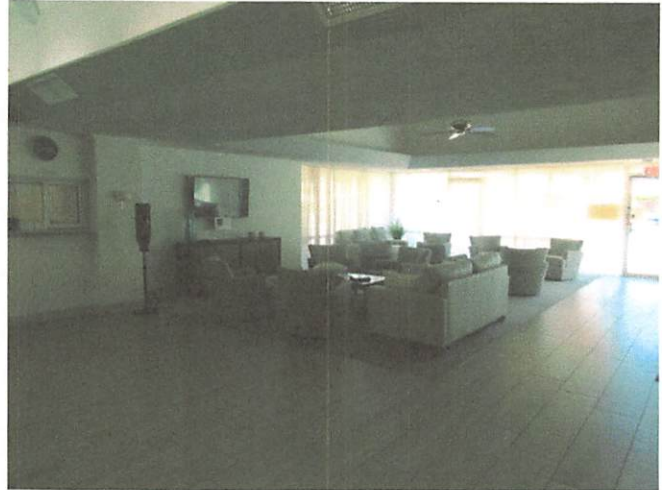
PHOTO 19

VIEW OF CLUBHOUSE INTERIOR

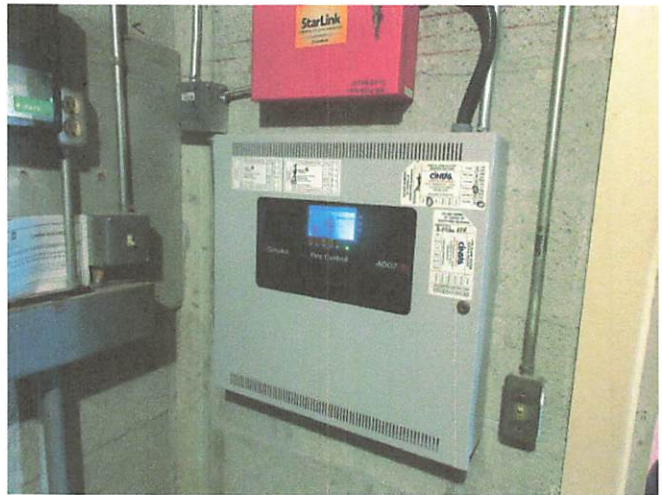
PHOTO 20

Item	Description/Observations/Comments
Fire Protection	<p>ABC-type portable fire extinguishers are in common areas.</p> <p>The Property's fire alarm systems utilize central panels for monitoring manual pull stations in the three-story buildings.</p> <p>The fire extinguishers were noted to be in general condition requiring routine maintenance over the evaluation period.</p> <p>The central alarm panels were noted to have been replaced in 2018. Central fire alarm panels typically have an EUL of 25 years. Funds have been spread throughout the Replacement Reserves Cost Estimate Table, adopting the straight-line accounting method to ensure the availability of funds at the end of the replaced element's EUL, beyond the evaluation period of this assessment.</p> <p>Fire protection and life safety systems within the dwelling units are reported to be the responsibility of the respective condominium unit owner to maintain and replace.</p>

VIEW OF CENTRAL ALARM PANEL

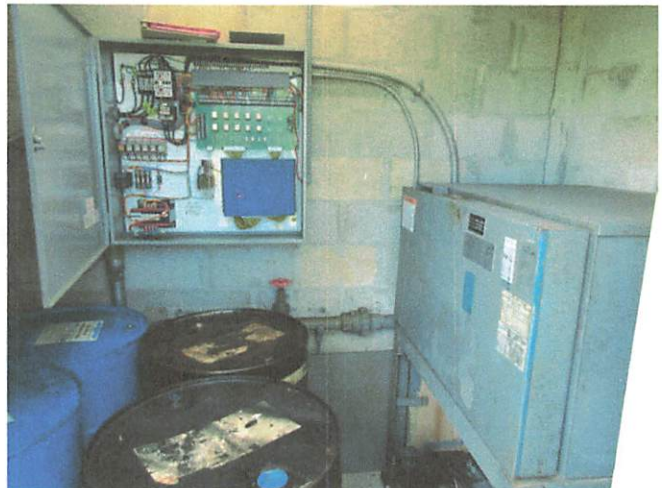
PHOTO 21

Item	Description/Observations/Comments
Elevators	<p>Each three-story building is equipped with one hydraulic elevator, rated at 2,500 pounds of load capacity, providing access to all floors.</p> <p>The elevators were noted to be in generally good operating condition and reportedly serviced regularly by an elevator service contractor.</p> <p>Elevator hydraulic pumps at Buildings 1, 2, 5, 6, and 11 were replaced in 2022 and Building 8 in 2023. The elevators were reportedly modernized between 1999 and 2008. Elevator hydraulic pumps typically have an EUL of 40 years and elevator controls an EUL of 25 years. Older elevator equipment should be anticipated to require upgrade / modernization during the evaluation period. Funds have been spread throughout the Replacement Reserves Cost Estimate Table, adopting the straight-line accounting method to ensure the availability of funds at the end of the replaced element's EUL beyond the evaluation period of this assessment.</p>

VIEW OF ELEVATOR EQUIPMENT
